**Re: Dorado Wastewater Treatment Plant
Quintas de Dorado Development Wastewater Collection System
Administrative Compliance Order
Docket Number CWA-02-2016-3103
NPDES Permit PR0020460**

Dorado Wastewater Treatment Plant
Quintas de Dorado Development Wastewater
Collection System

**ADMINISTRATIVE
COMPLIANCE ORDER AND
INFORMATION REQUEST**

**DOCKET NUMBER
CWA-02-2016-3103**

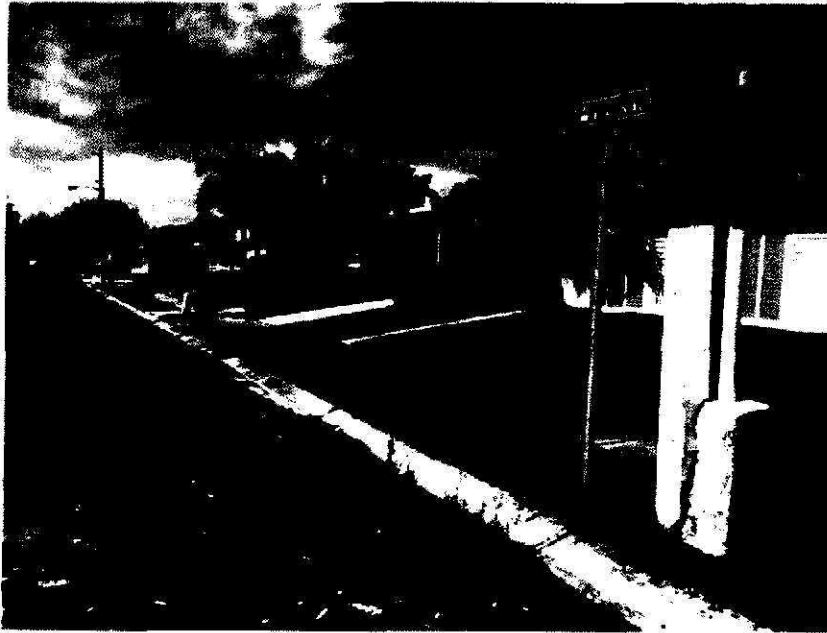
Photo No. 5.

Another view of the sanitary solids of a recent SSO event that were observed over the street at Ucar Street intersection with Cipres Street. The sanitary solids were observed at the storm water gutter.

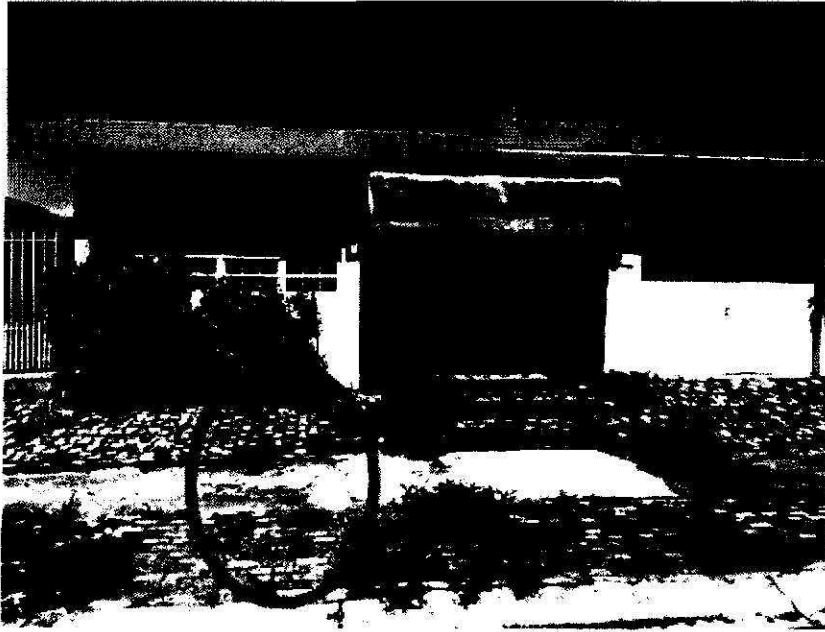
Photo No. 13.

11. Solids of sewage nature were observed in front of Residence #58 located at intersection of Nogal Boulevard and Mirto Street. The cleanout (i.e., sanitary service connection) cover was observed removed. Sewage was observed around the cleanout and driveway of the residence. The overflowed sewage was observed over part of the street due to a recent sanitary sewer overflow event. See attached Photo No. 13 through 16 in Appendix IV.

Solids of sewage nature were observed in front of Residence #58 located at intersection of Nogal Boulevard and Mirto Street. Sewage was observed around the cleanout and driveway of the residence. The overflowed sewage was also observed over part of the street due to a recent sanitary sewer overflow event.

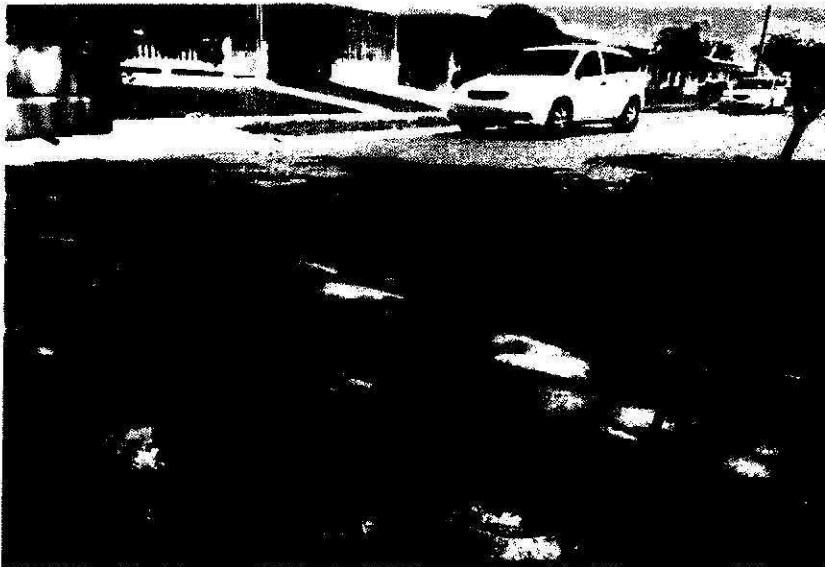
Photo No. 17.

12. The sanitary manhole cover in front of residence H-57 at Nogal Boulevard had solids of sewage nature around it. It has a huge amount of solids accumulated inside the manhole. Solids of sewage nature were observed over the street next to the sanitary manhole. In addition, solids of sewage nature were also observed at the storm sewer gutter next to the sanitary manhole. According to Mr. Samuel Rosario, PRASA's Toa Alta Area Plant Manager, this sanitary manhole receives sewage from Ceiba Street, Eucalipto Street and Brighton Development Walkups and also from other local commerce. See attached Photo No. 17 through 19 in Appendix IV.

View of a sanitary manhole and cover in front of residence H-57 at Nogal Boulevard. This sanitary manhole had solids of sewage nature around it. It also had a huge amount of solids accumulated inside. Solids of sewage nature were observed over the street. In addition, solids of sewage nature were also observed at the storm sewer gutter next to the sanitary manhole.

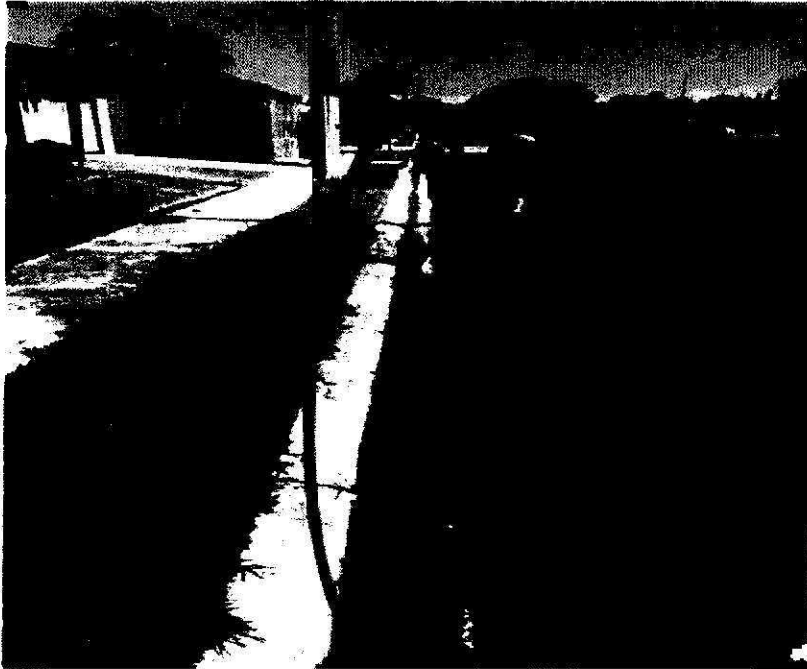
Photo No. 21.

The photo shows sewage and solids of a recent SSO event. Mrs. Dimaris Miranda, resident of P-17 at Ucar Street, said that she is affected by bad odors due to SSOs occurring at her street.

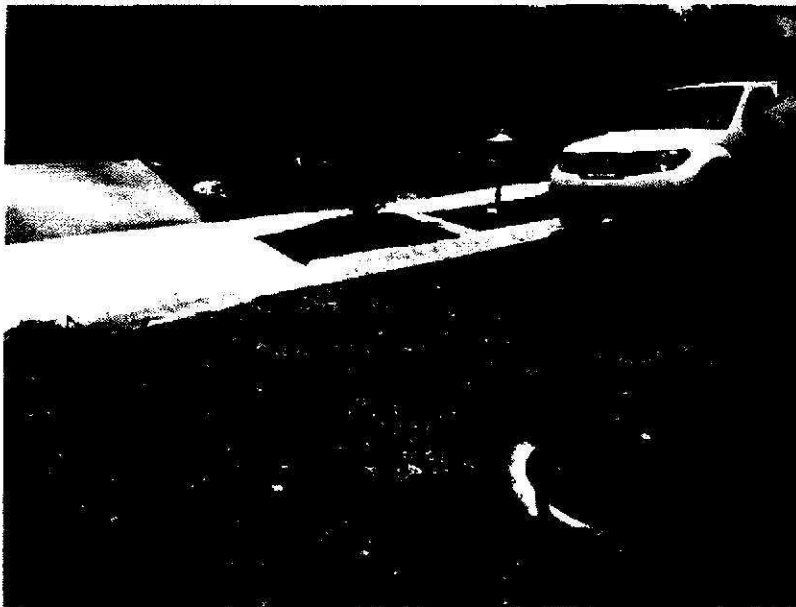
Photo No. 22.

- j. The sanitary manhole located in front of residence H-12, Ceiba Street, has too much solids (e.g., grease, etc.) inside it. In addition, solids of a recent SSO event were observed over the Ceiba Street and also at the street storm sewer gutter next to the sanitary manhole. Solids such as paper, grease, cloths, among others (all of sewage nature), were also observed next to a storm sewer catch basin (i.e., storm drain) located at the Ceiba Street and near residence H-12. See attached Photos No. 22 through 24 in Appendix IV.

The sanitary manhole located in front of residence H-12, Ceiba Street, has too much solids (e.g., grease, etc.) inside it.

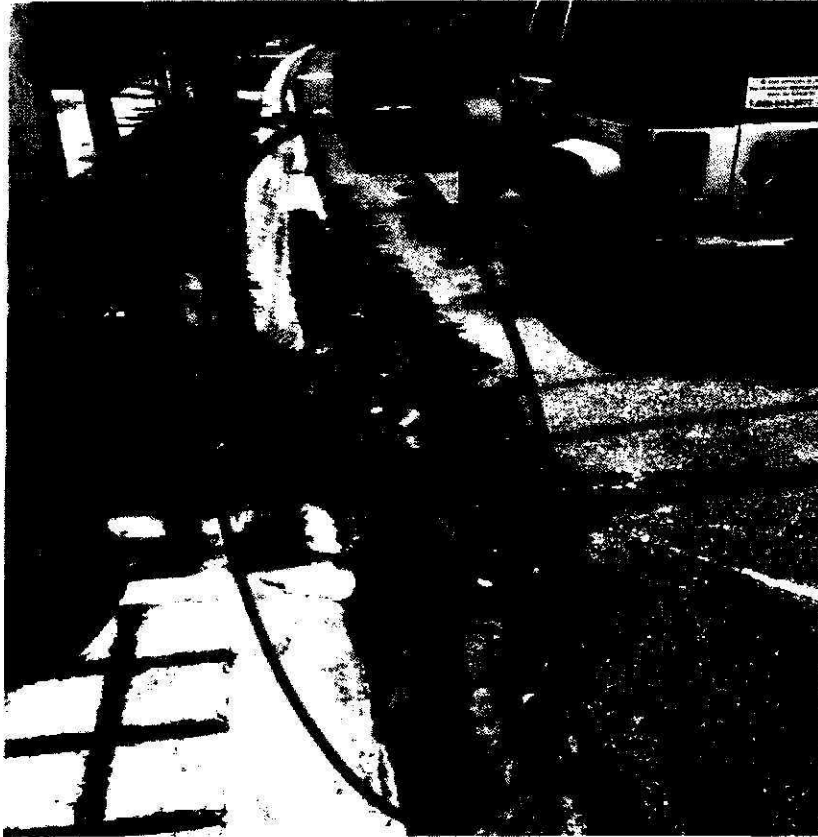
Photo No. 25.

- m. Mrs. Zelma Alvarez, resident of B-24 at Nogal Boulevard said that SSOs has causes sewage back-ups into her residence through the toilet and bathtub. She also said that she used to open the clean out (i.e., sanitary service connection) to avoid sewage back-ups inside her house. Solids of sewage nature were observed in front of her residence B-24 and also in front of residence B-23. Mrs. Alvarez showed the inspector the clean-out of residence B-23 which she alleged also that sanitary sewer overflows occurred reaching over the concrete sidewalk located in front of residence B-23 and flowing down to her residence (B-24). In addition, Mrs. Alvarez complained about the bad odors emanating from PRASA's Quintas de Dorado Sub-trunk Sewer during dry weather. See attached Photos No. 25 through 28 in Attachment IV.

View of sewage and solids of a recent sanitary sewer overflow event in front of residences B-23 and B-24 at Nogal Boulevard.

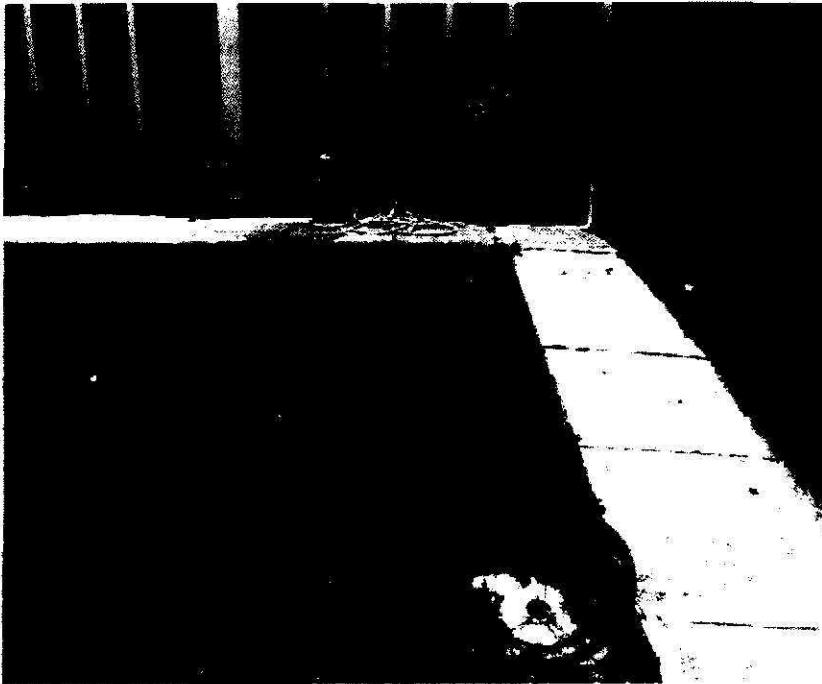
Photo No. 26.

- n. Mrs. Nurquis Santana, resident of B-23 at Nogal Street, said that sanitary sewer overflows has caused sewage back-ups inside her residence through the toilet and bathtub. She also said that she used to open the clean out (i.e., sanitary service connection) to avoid sewage back-ups inside her house. In addition, Mrs. Santana said that she has observed sanitary sewer overflows from PRASA's Quintas de

View of un-capped cleanout (i.e., sanitary service connection) at Residence B-23 at Nogal Boulevard. Mrs. Nurquis Santana, resident of B-23 at Nogal Boulevard, said that sanitary sewer overflows has caused sewage back-ups inside her residence through the toilet and bathtub. She also said that she used to open the clean out (i.e., sanitary service connection) to avoid sewage back-ups inside her house.
